Subject: Slurry Wall Reconstruction - CQA Acceptance Report
 Gary Sanitary Landfill
 Gary, Indiana

Construction Quality
Assurance Acceptance
Report

Slurry Wall Repair
Gary Landfill
Gary, Illinois

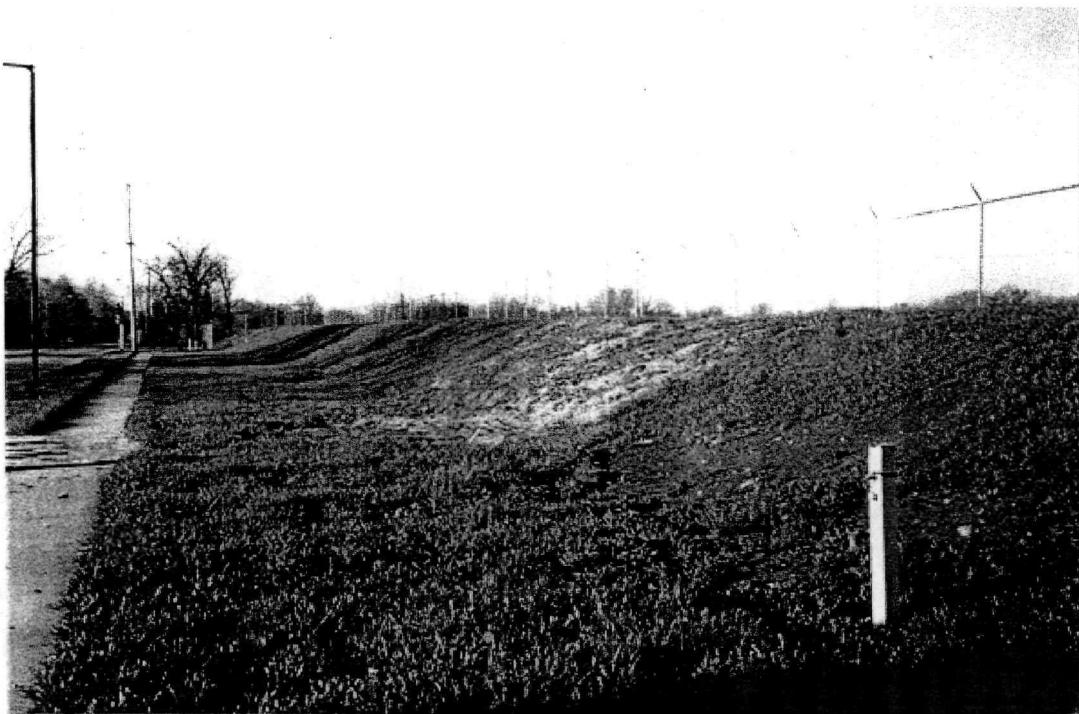
Photo # 1 (Facing south). Site before repair work began. View is looking south with Burr St. on the left and Gary Landfill on the other side of the fence. GP-4 is the 3 ft tall rectangular structure protruding from the grass in the lower right corner of the photo.

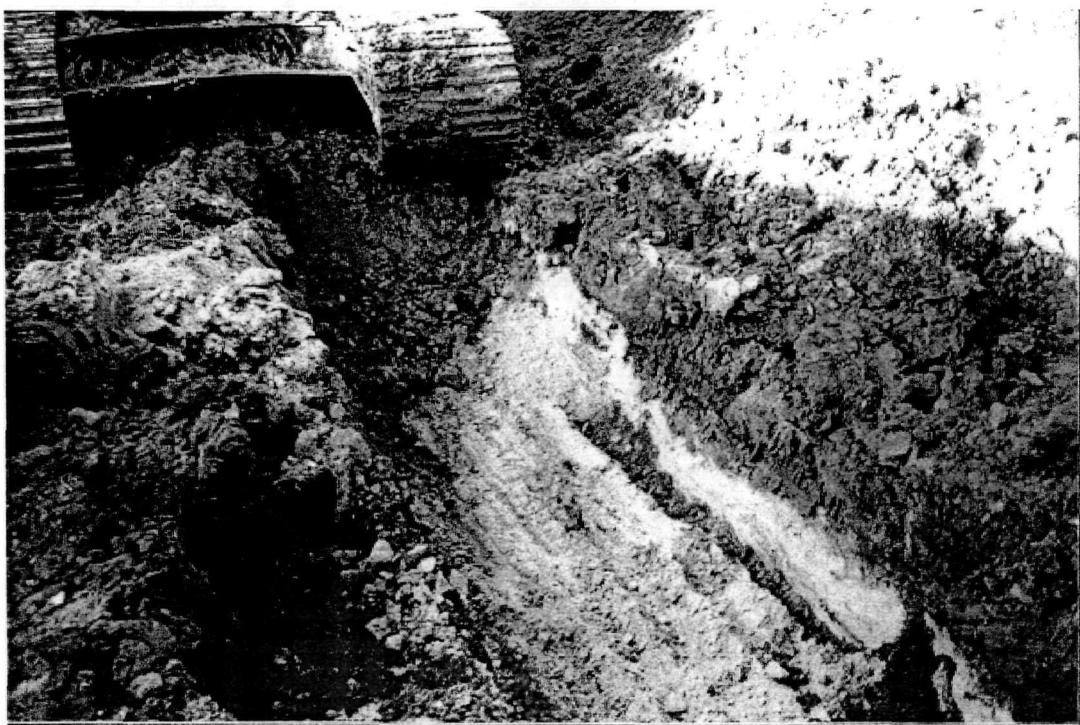
Photo # 3 (Facing southwest and down). The existing slurry wall is exposed and can be seen here as the bluish gray colored material in the sandy soil.

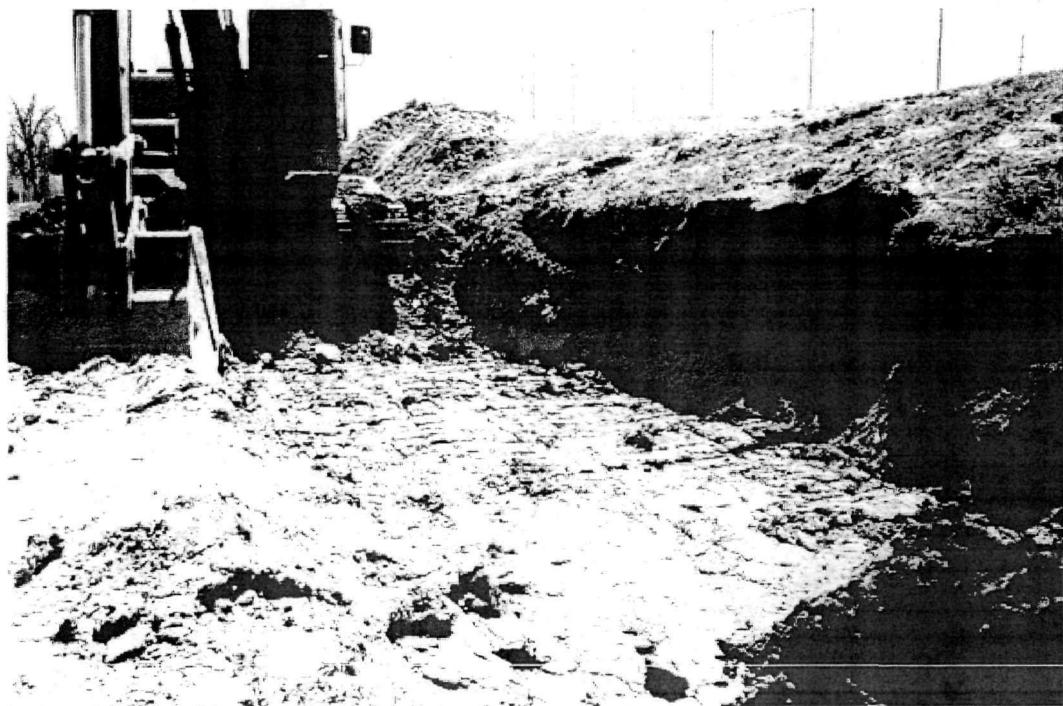
Photo # 4 (Facing south). The clay repair material is placed in lifts of 6 inches thick and receives compaction from the downward pressure of the track hoe scoop.

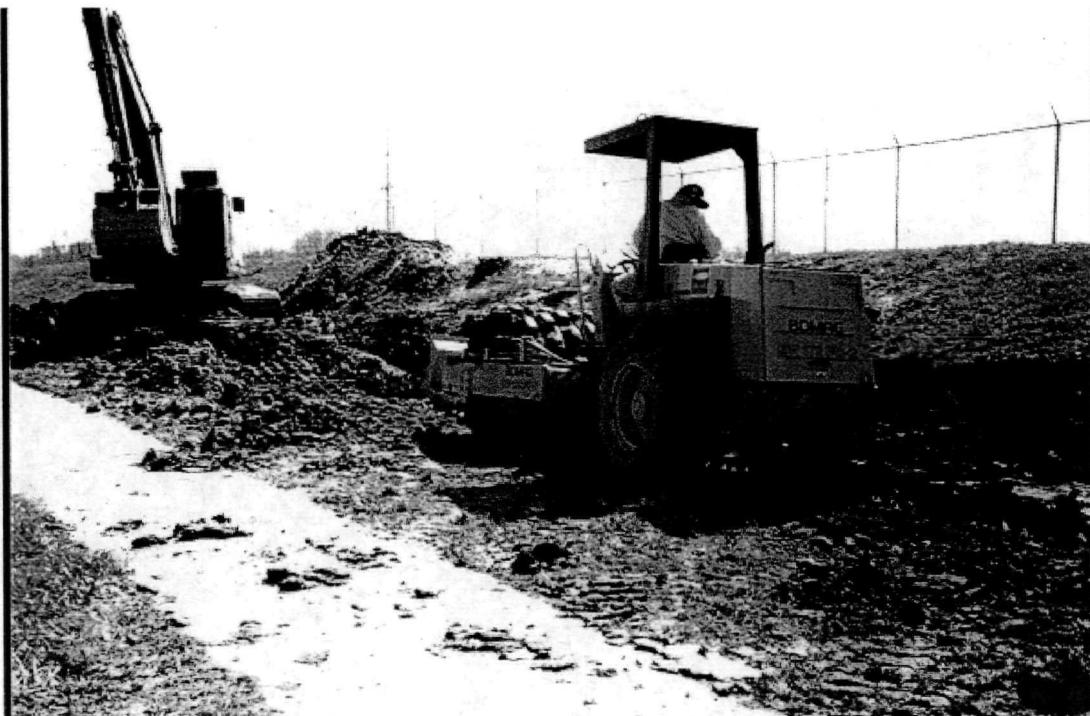
Photo # 5 (Facing southwest). The clay repair material is placed in lifts of 6 inches thick and achieves compaction by using a sheep's hoof roller compactor.

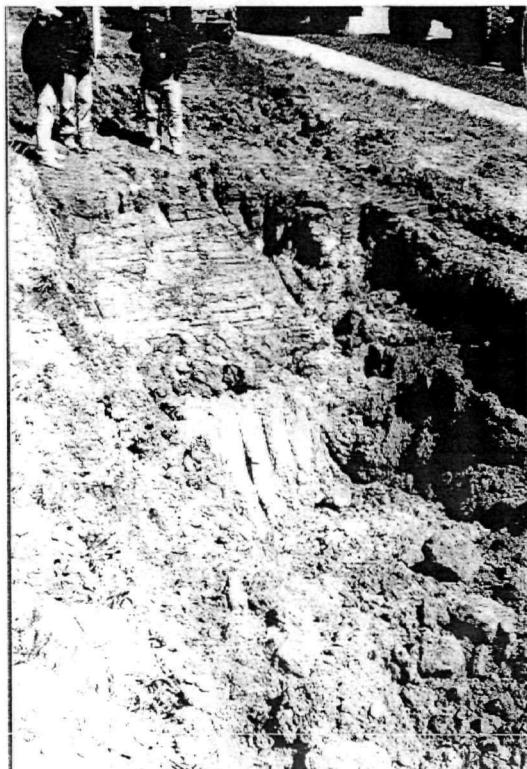
Photo # 6 (Facing north east). The repair to the slurry wall was made in three increments. The second repair increment is being excavated here. Where the people are standing is the first repair increment, which has received compacted clay repair material.

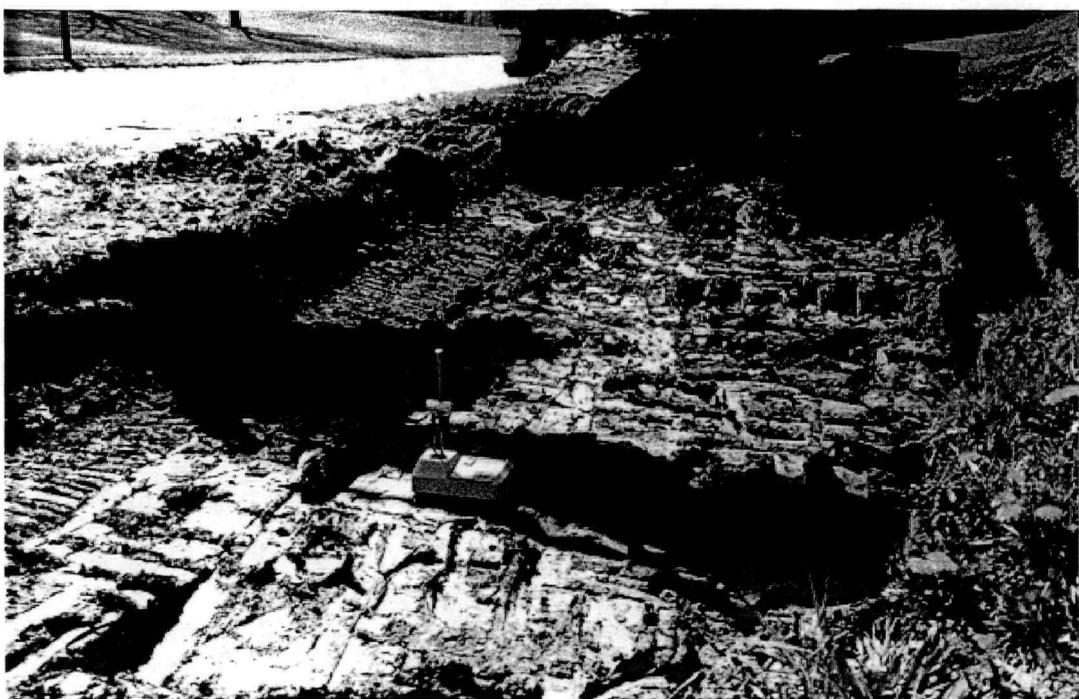
Photo # 7 (Facing southeast). After compaction a smooth surface was made using the track hoe scoop where in-situ soil testing was performed with nuclear density test equipment.

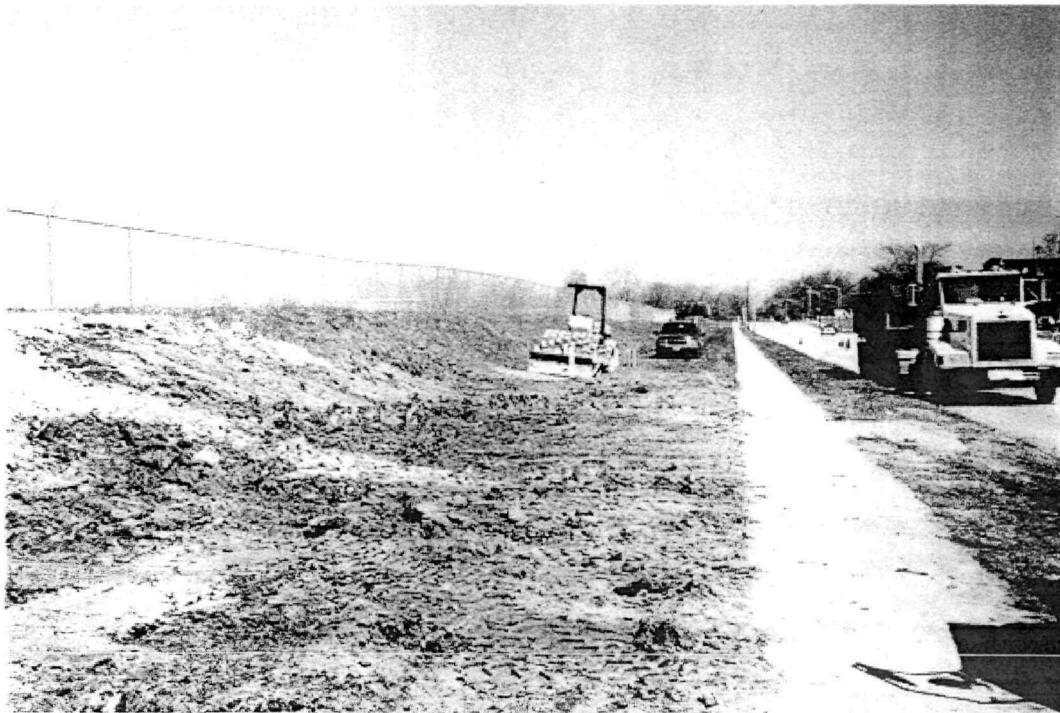
Photo # 8 (Facing north). The final lift of clay was placed across the entire area of repair and compacted. Rough grading was made in preparation for placement of topsoil.

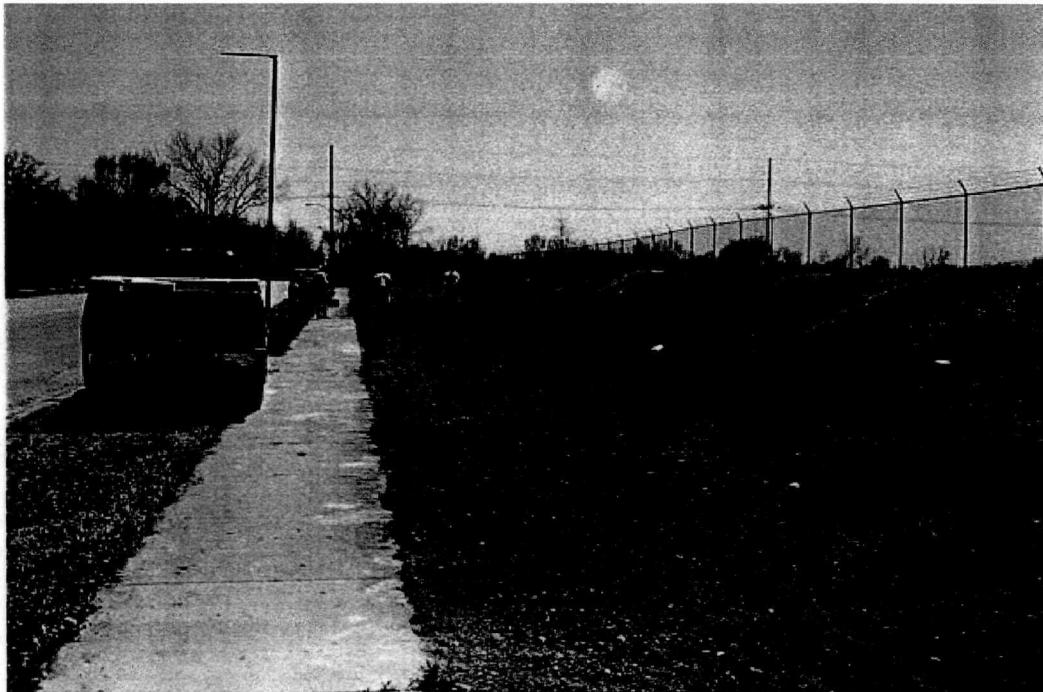
Photo # 9 (Facing south). Topsoil was placed and spread to transition smoothly with former grades. Then grass seed was applied to areas devoid of vegetation.

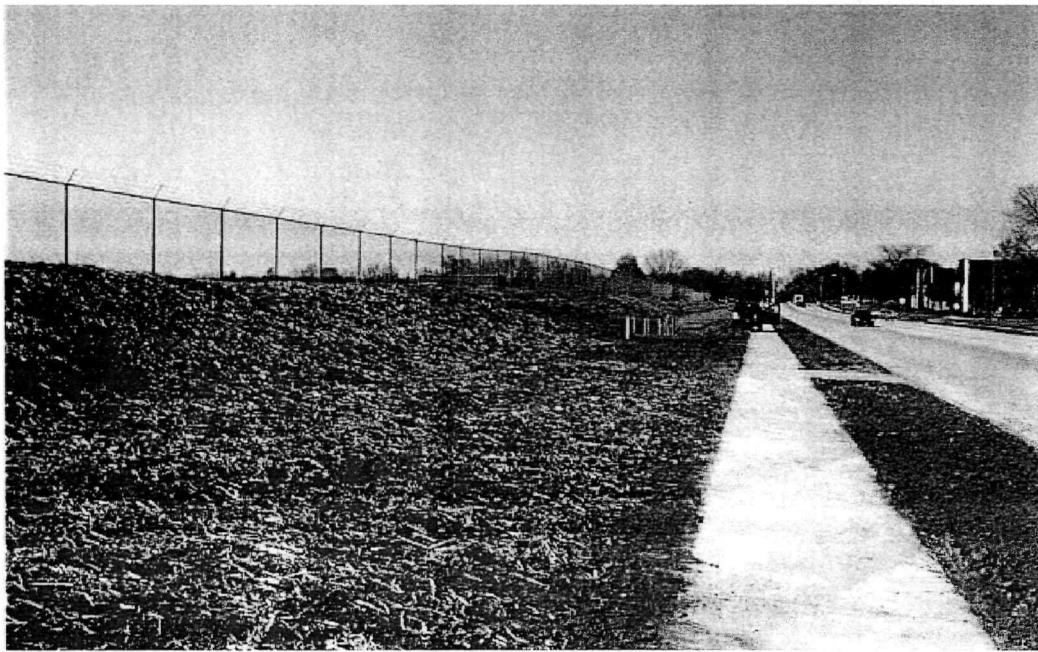
Photo # 10 (Facing north). Straw was applied to complete the seeding activities.
